Technical Memo: Partition Separation

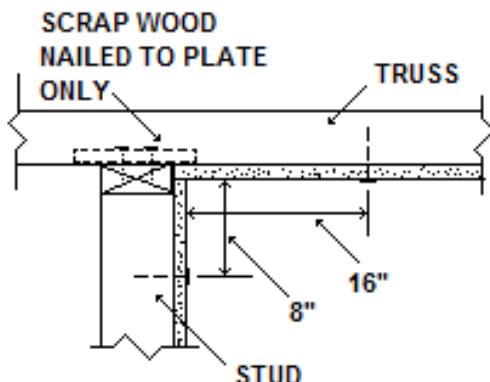
Figure 1

Partition separation shows as gaps that develop between interior partition walls and ceilings or floor finishes, usually characterized by opening in winter and closing in summer. Partition separation is usually worse during the first year after construction when the house is drying out.

There are numerous causes of partition separation. Truss design and manufacture is sometimes singled out as the cause of the problem, **but this is not correct**. Truss design and manufacture has little control over partition separation. It has been recognized that partition separation is a result of truss movement **less than 20% of the time**.

Insist that the drywall contractor use floated corners at interior non-bearing walls for instance as illustrated in Figures 1 & 2 below. Note that the first row of fasteners should be doubled to prevent pull-through.
